Re: **New Dock at Lot #26 Shelter Cove, 4401 Westside Road, Regional District of Central Okanagan, BC - Environmental Assessment**

The following letter report provides an environmental assessment of a new dock proposed for Lot #26 at Shelter Cove on the west side of Okanagan Lake near Kelowna, BC.

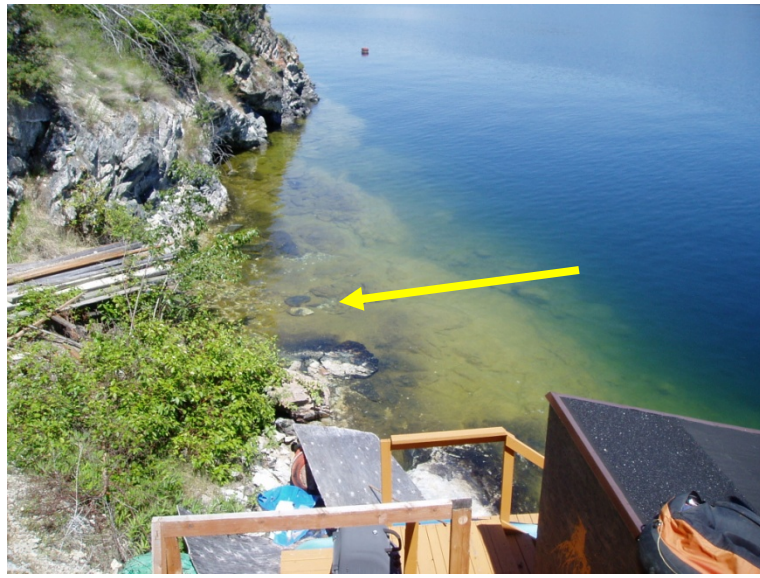
The dock location has a narrow bedrock shelf approximately 5 m wide (Photo 1, Figure 2), with 10-25 cm rubble (broken rock) 7-9 m out from the high water mark before a sharp dropoff where depth increases rapidly. There was a thick layer of periphyton coating the substrate. Some stems of aquatic plants, suspected to be Eurasian watermilfoil (*Myriophyllum spicatum*), were present. Okanagan Lake water level³ on the survey date of June 11, 2012 was around 342.42 m, approximately 10 cm less than the normal high water level and 0.6 m below the extreme high water mark (HWM) of 343.0 m.

Photo 1.
Looking down at approximate proposed dock location (yellow arrow) showing bedrock shelf and abrupt dropoff to deep water.
Jun 11/12

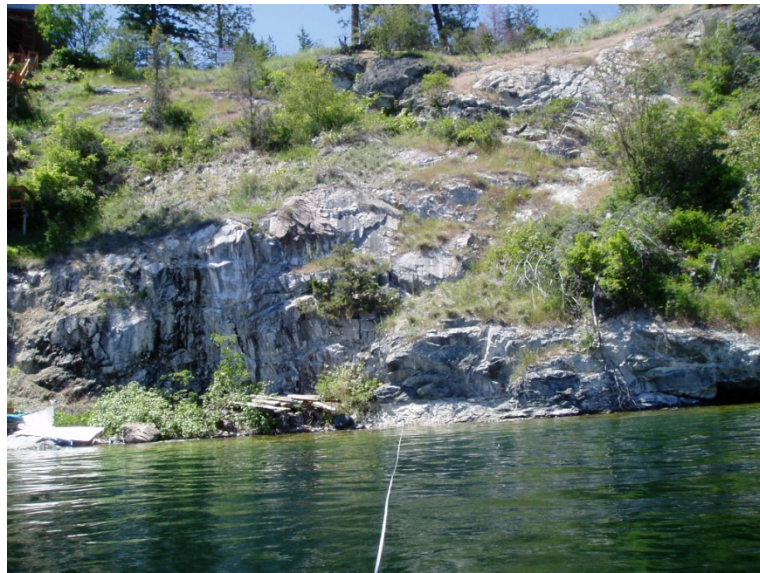
Vegetation at the site (Photos 1, 2) included typical riparian species such as red-osier dogwood near the water's edge and those common to a dry, bedrock-dominated site further upslope (Table 1).

Photo 2.
Looking in along proposed dock alignment.
Jun 11/12

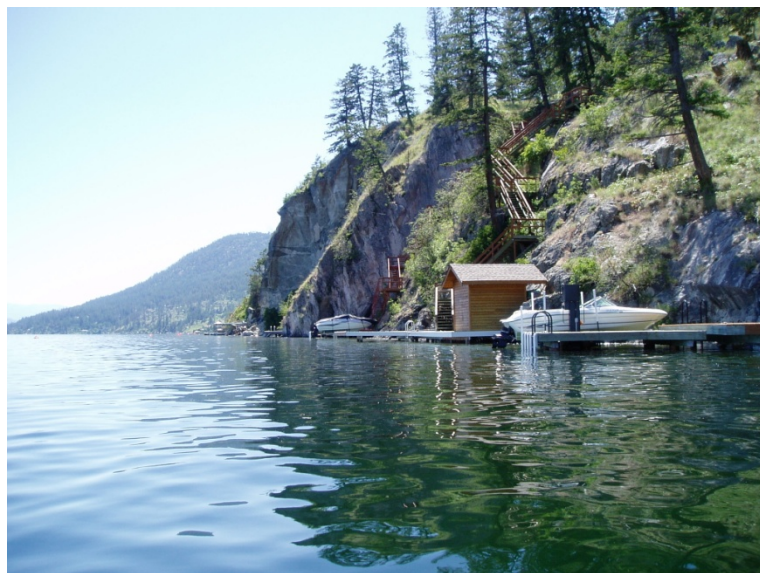
Consistent with the good shore spawning potential, the shoreline at the dock site is a red zone (very important habitat) under the OLLP, which is a classification assigned to areas where kokanee spawners are consistently observed. The colour zone changes to black (critical habitat) only 60 m north of the dock location (Figure 3). There are several other existing docks or platforms along this section of lakeshore, with adjacent docks located less than 10 m south (Photo 3) and 35 m north (Photo 4).

Photo 3.
Looking south from proposed dock location showing existing shoreline development.
Jun 11/12

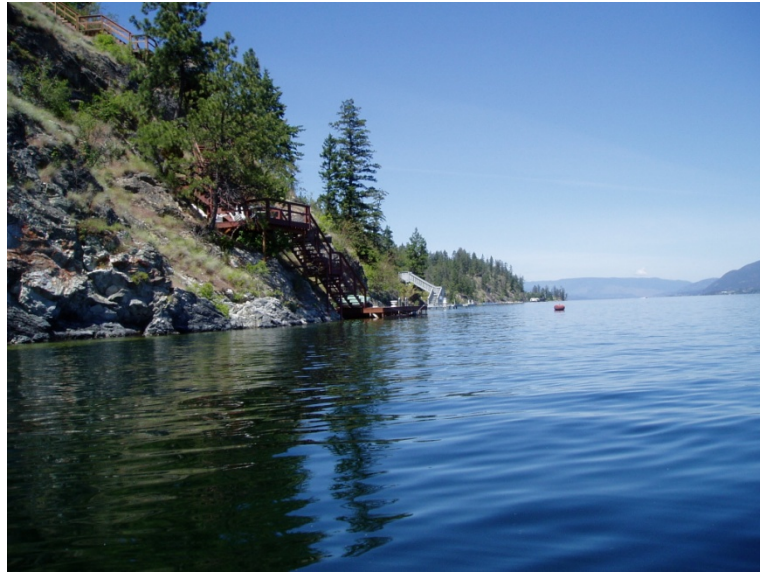
Photo 4.

Looking north from proposed dock location showing existing shoreline development.
